Results of RFQ "fixes"

C.Y. Tan, J. Schmidt, B. Koubek, D. Bollinger, P. Karns, R. Tomlin 16 May 2012

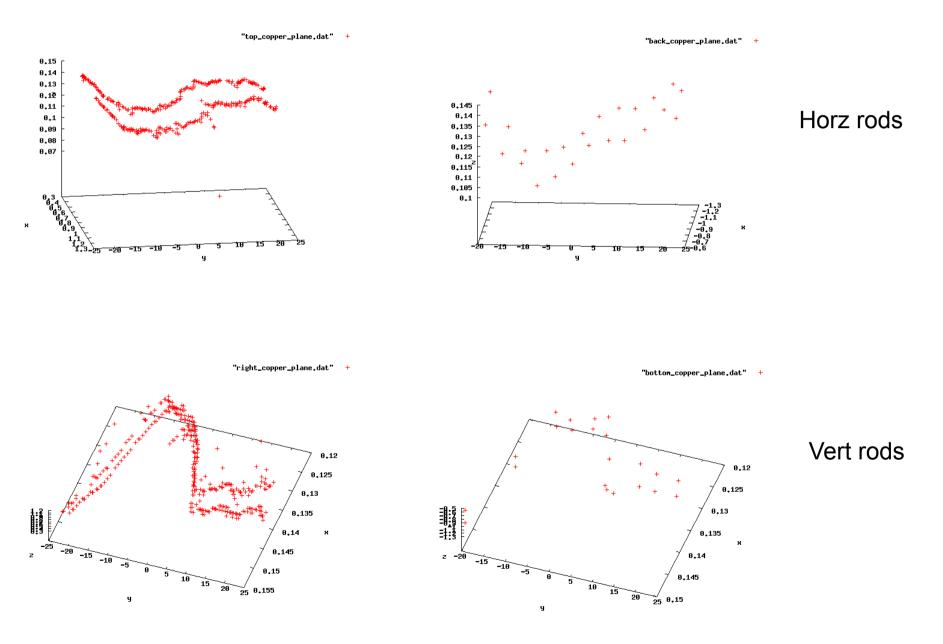
Survey of RFQ

Correlation between warpage and stand angle

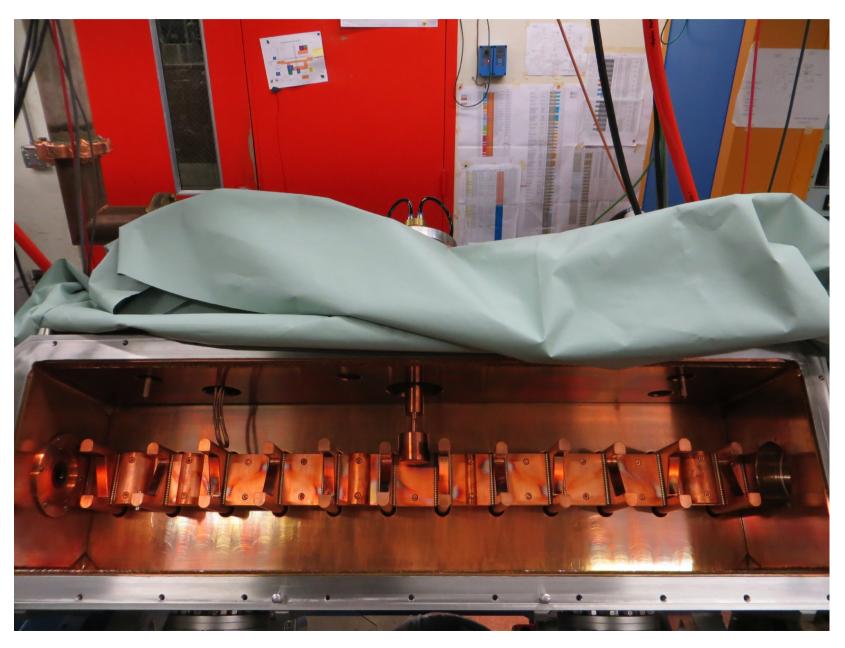
Stripping the RFQ

Longitudinally misaligned rods

~0.25 mm misalignment

- Straightened the stands by evenly tightening the bolts of the stands.
- Rods are straight and longitudinally aligned.
- Only one of the rods have dowel pins used to hold to the stands. Other 3 rods do not have dowel pins.
